WILDLIFE

Natural materials enable erosion control

by Steven Smith / sgsmith@noble.org

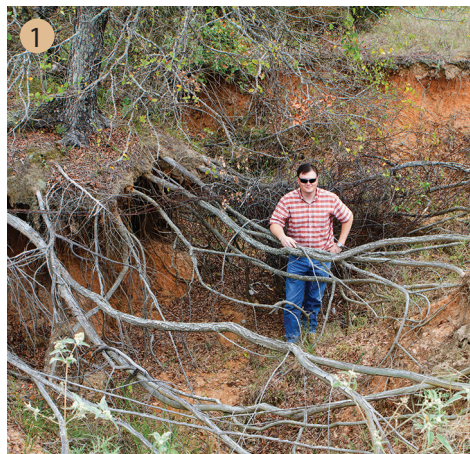
The gully in Figure 1 was present on the McMillan East Farm when the Noble Foundation began managing the property in 2008. We think the land above the gully was farmed in the past. This gully was approximately 20 feet wide at the widest point and 15 feet deep at the deepest. We used 20 to 25 old round bales to fill the gully as seen in Figure 2. Typically, many landowners fill gullies like this with tires, rocks, concrete or other

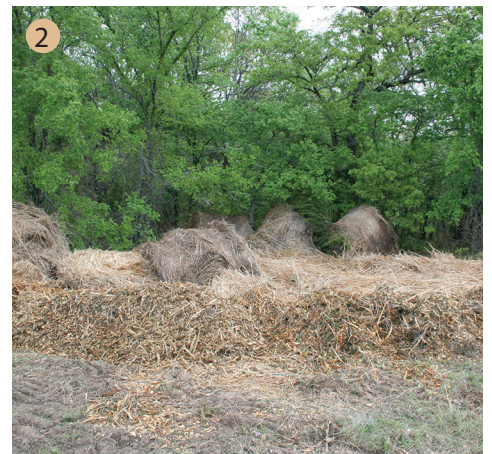
hard materials. We chose to use round bales because they would serve as a temporary soil for vegetation to establish. The round bales also act as a sponge, soaking up water, as well as slowing and redirecting the water.

We also created a small diversion terrace made of mulch donated by a local tree trimming company. The mulch terrace helps protect the head cut (the ledge where water enters the gully). Reducing the amount and ►

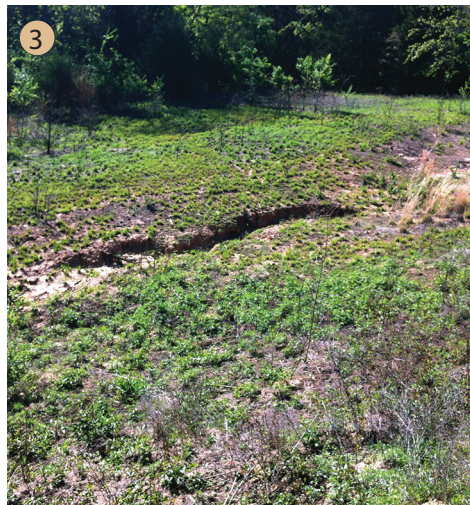
| <p>speed of water entering a gully is necessary to reduce future erosion. Properly implemented land use practices are the key to preventing erosion from starting. All this work was completed with a farm tractor with a front-end loader equipped with a bale spear and bucket.</p> <p>The eroded area in Figure 3 was created by water running off the same</p> | <p>field with the abovementioned gully. In this area, all the topsoil was completely eroded away leaving only subsoil, which is not conducive to plant establishment and growth. A gully had begun to form approximately 30 yards from the edge of the exposed subsoil. This gully was roughly 4 feet wide at the widest point and 3 feet deep at the deepest. Due to the small-</p> | <p>er size of the area, we were able to fill the gully with soil from old brush piles. This soil replaced the missing topsoil and added existing vegetation. To protect this new soil and facilitate vegetation establishment, we created several mulch terraces to slow excess runoff and capture soil (Figure 4). The captured soil will help provide a place for vegetation establishment. ■</p> |
